Cutting holes for testing vs. testing for holes

When it comes to geomembrane quality assurance, are destructive testing practices as effective as basic leak detection technologies?

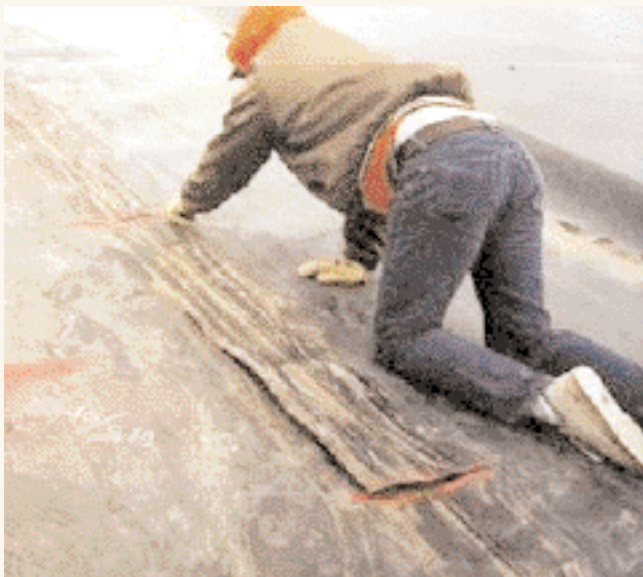
Photo 1. Cutting holes in geomembrane for testing.

acre of geomembrane. Each sample area is patched, which requires about 12 ft. (3.7 m) of inferior manual extrusion welding. The samples are tested for shear and peel strength at stresses that are many times higher than the stresses the seams will experience in service. Assuming a 10-acre (4-ha) landfill, 600 ft. (183 m) of extrusion welding is needed to take the samples. On average, 3% of the samples do not pass the destructive test. For the 10-acre landfill, this would mean an average of 1.5 samples not passing the destructive test. These areas would require another 63 ft. (19 m) of extrusion weld. So to test a fraction of a percent of the superior dual-track fusion welded seams, an additional 663 ft. (202 m) of inferior extrusion welding must be made on an average 10-acre landfill. This leads to the question of whether testing the 663 ft. of extrusion welds would result in another sample not passing a destructive test.

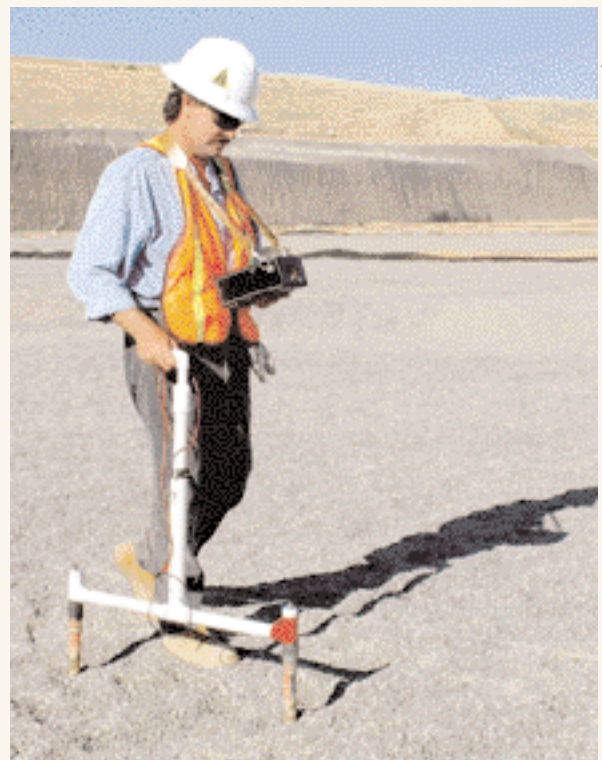
Photo 2. Testing geomembrane for holes and cuts.

The electrical leak location method is to impress a voltage across the geomembrane, then detect the points where electrical current flows through the geomembrane. This is a well-established technology used in the CQA of geomembrane liner installations. The development of the technology was initiated by the U.S. EPA. in 1980. The first commercial leak location surveys for soil-covered and water-covered geomembranes were performed in 1985. There is an ASTM Standard Guide for selection of electrical methods for locating leaks (ASTM 2002). In addition, ASTM standards are currently being prepared for testing soil-covered, water-covered, and bare geomembranes. In the case of landfills, the method can be applied after protective drainage ma-

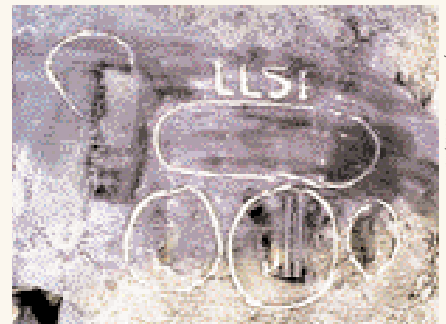
Photo 3. A widespread problem of construction damage: Bulldozer track cuts in geomembrane.

But then the counterattack begins, and the enemy is using armored weapons! Good CQA practice dictates that a full-time observer should be stationed in front of a bulldozer blade spreading gravel over a geomembrane to watch for potential damage to the geomembrane. Although costly for the owner and unglamorous for CQA personnel, experience has shown that this is really the most critical time of the battle; this is when the most damage can occur.

Nosko et al. (1996) reported on electrical leak location surveys for more than 100 sites where several thousand areas of damage were found. Of these, 73% were construction damages caused during the installation of the covering layer. Only 24% of the damage found was caused during the installation of the geomembrane, and 61% of those leaks were found mainly in extrusion welds. These data match the extensive experience gained by the authors using leak location surveys.
